## LIFESPAN IMPROVEMENTS AND OPTIMISATION OF CLASSIFICATION CYCLONES

### CHALLENGE

A cluster of four 380mm De-watering Cyclones were sent in to HMA for refurbishment. They were originally lined with 12mm alumina tiles. Our client requested we propose methods to increase the service life of the items.

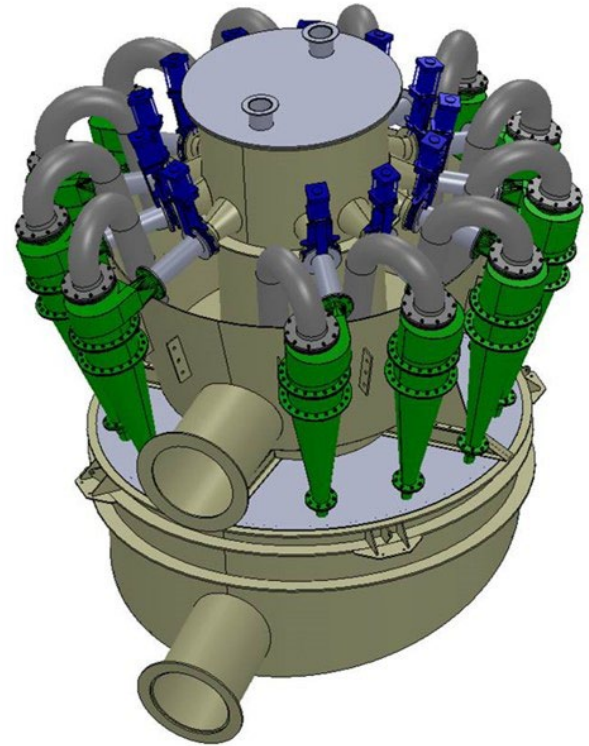
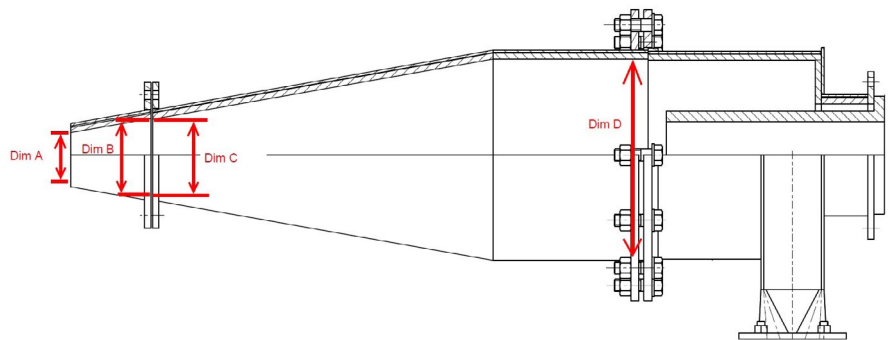
Once disassembled, the cyclone components were examined internally with measurements being taken at each of the locations shown on the diagram above, these are shown below in the table along with the 'As New' dimensions:

As you can see, there was minimal difference between the measured internal dimensions and the 'as new' dimensions (\*apart from the one item that was

damaged in transit). The difference between the design measurement and the actual measured items could even be attributed to manufacturing tolerances, this indicated there were no signs of measurable wear in the HMA SiTech components.

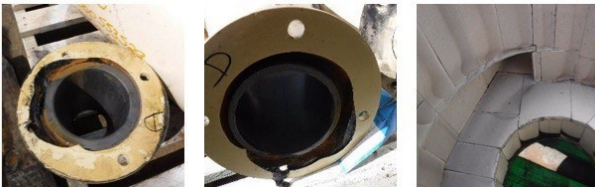
The pictures above show there was no visible signs of wear at all on the HMA SiTech components, whereas the Alumina components were visibly worn with heavy scalloping. Traditionally the inlet head is the component subject to the least amount of wear but as you can see in the photos, there is heavy scalloping on the tile faces, whereas on the lower components where the material velocity is higher, it was actually the gasket joint which had failed with material chewing through the steel with the ceramic completely intact.

Our recommendation was to remove the nozzle flange joint, lining the cyclone completely from inlet head through to nozzle discharge with HMA SiTech, removing the potential failure point. HMA engineering utilises special joints between SiTech components to overcome fines egress at joints. The secondary recommendation was the replacement of the inlet head alumina tiles with a one piece HMA SiTech liner. This will increase the service life of the cyclones, replicating the minimal wear of the SiTech in the lower cone sections into the inlet head. As all cyclones act under centrifugal forces with sliding abrasion on the internal lining, the removal of tile joints provides a smoother surface which leads to less turbulence and improved cyclone performance.
