Case Study

INSTRUMENTATION UPGRADE AT UPPER YARRA DAM, VICTORIA

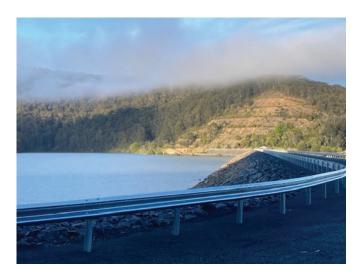
Figure 1 Upper Yarra Dam after crest upgrade

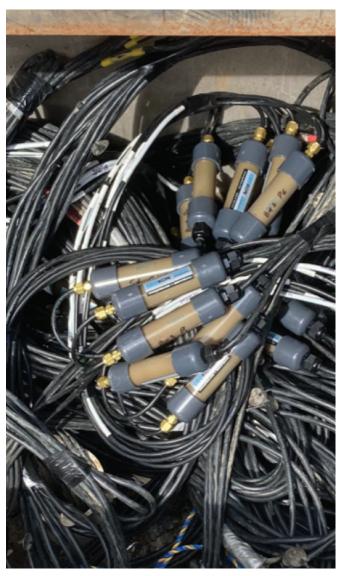
Figure 2 - Cables spliced in access pit

Cable splicing was carried out using Geokon cable splice kits. The kits had to be reworked to allow two cables at different diameters to be connected. Before and after readings were taken on each splice, before potting, to ensure continuity and stable readings.

Sufficient new cable was spliced onto the existing cable to reach the two new logging systems installed at the southwest end of the dam.
