## INCREASING WEAR LIFE OF CYCLONE DISTRIBUTOR

Cyclone Distributor / Alumina & SiTech / Gold

**Location** Central Queensland  
**Industry** Gold Processing

WEA-CS-0025 AUG 2018

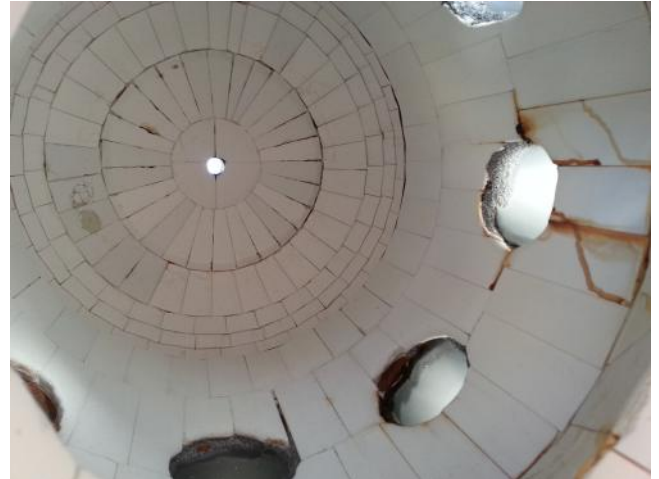
Previous distributor had a poor lining method used by a competitor

HMA Wear Solutions was approached by the client to provide a solution to increase the life of the cyclone distributor used on site. The way our competitor had lined the distributor was allowing for premature failure at the junction of the arms to the distributor body. With the plant going 6 months between shutdowns, our client needed a better solution. We needed to eliminate the requirement for maintenance between the shutdowns.

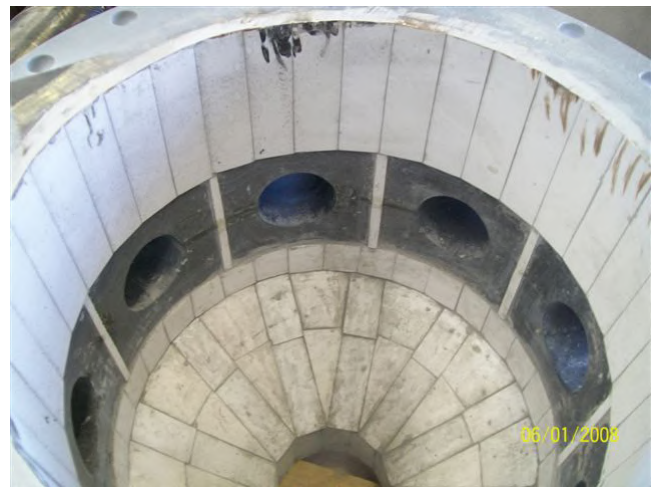
HMA distributor with full SiTech arms that extended into the main body with a radius plate as a one piece design

HMA Wear Solutions offered fully lined arms with SiTech (Silicon Carbide). These arms would extend into the main body with radius plates to protect the main wear area of the junction of the body and arms.

HMA also offered tight tile joints for the balance of the distributor body, with Monolithic Alumina cylinders at the feed into the distributor which matched IDs with the Alumina lined feed pipe.
