GTD900 UPGRADE PROJECT

DMC / Alumina / Coal

Location NSW Hunter
Industry Coal Processing

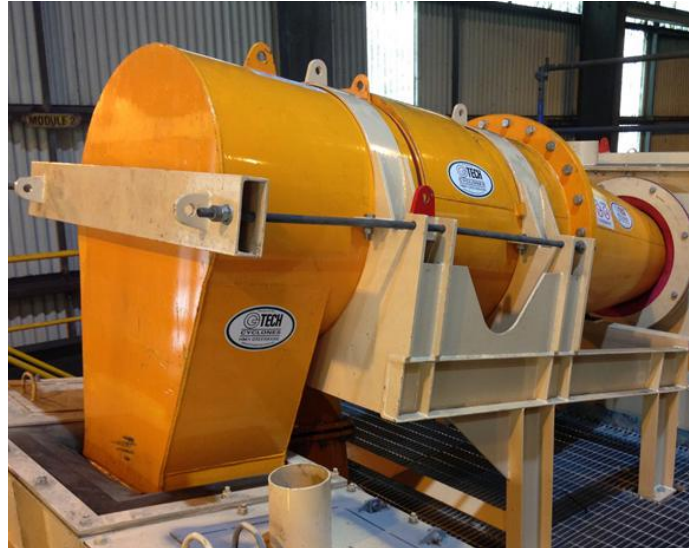
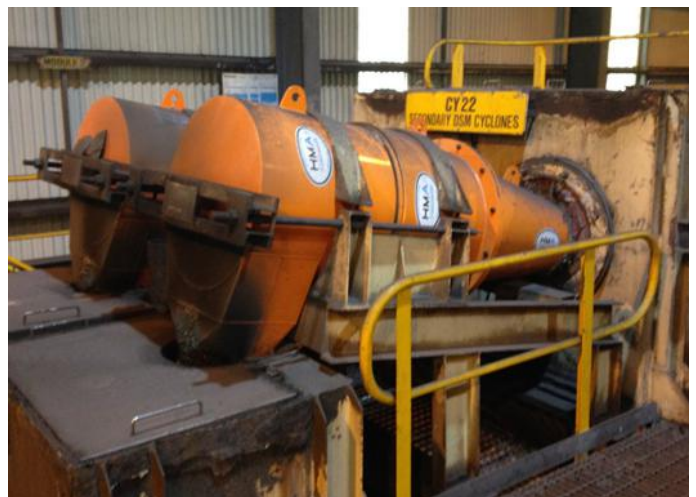
Site wanted to remove the Y-piece, simplify the maintenance of the cyclones and have the ability to increase the DMC's throughput if required. There are 12x GT710 cyclones installed at this site across two modules. 4x Primary and 2x Secondary cyclones per module.

Site operated two GT710 cyclones installed in parallel fed off a single pump with feed distributed through a Y-piece in both primary and secondary circuits. A Y-piece isn't ideal as a feed bias can be present, leading to increased wear in one cyclone. This results in poor cyclone efficiency which leads to a poor performing DMC circuit. Good maintenance practice is to replace any cyclones in parallel at the same time so that differences in internal configurations doesn't compound any feed bias issues.

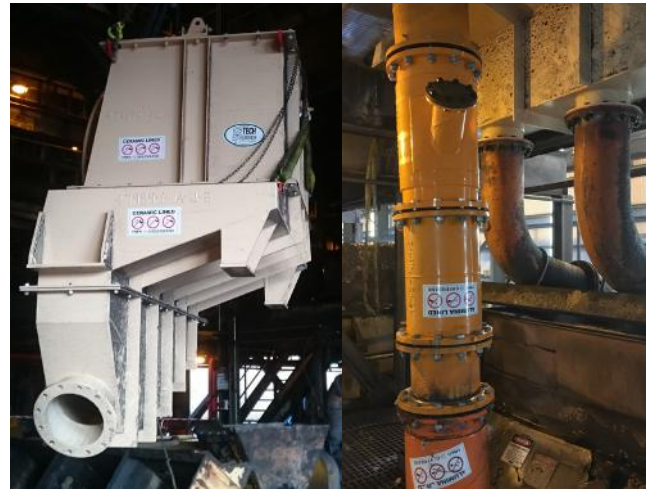
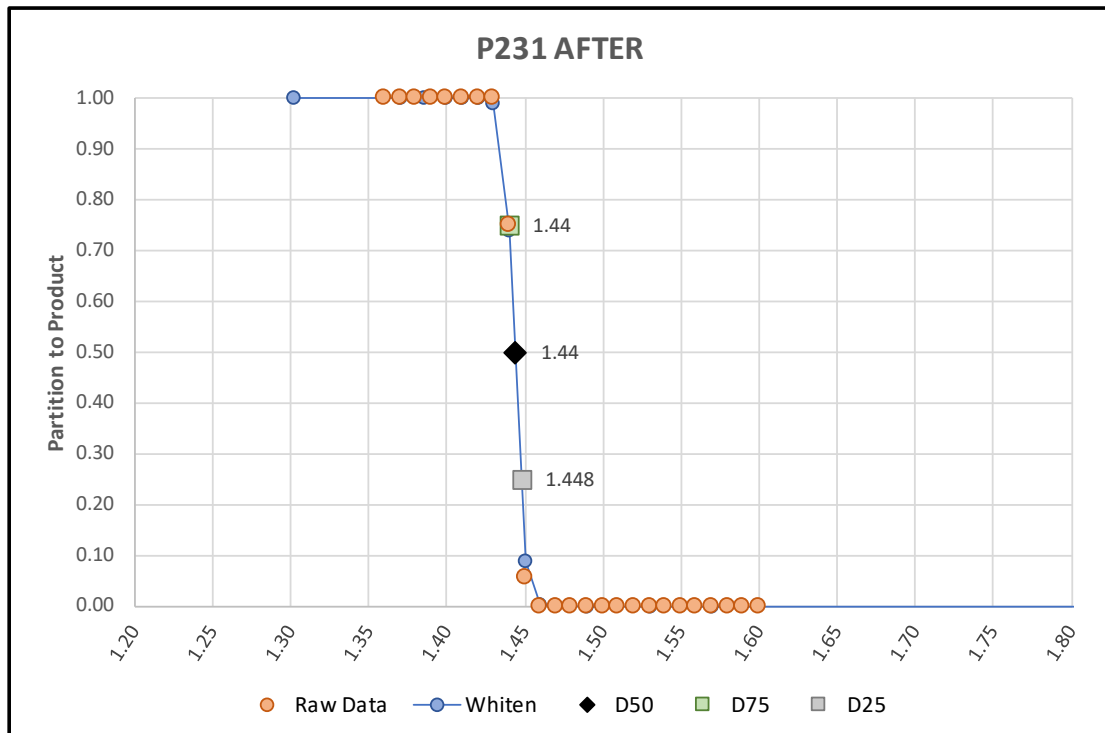
The performance of the cyclones was in line with HMA's expectations and site had the ability to increase pressure and throughput to test the new cyclones. The maintenance for these cyclones has been streamlined and the issue of feed bias, etc. has been removed. This has resulted in a reduced OPEX budget associated with these cyclones and also the potential to increase the cyclones installed life depending on the feed conditions, such as increased operating pressures.

STANDARD WHITEN		
Parameter	Before	After
Application	2 x GT710	1 x GTD900
D ₅₀	1.46	1.44
Ep (75-25)	0.005	0.004
Imperfection	0.011	0.009

HMA sized and selected a single cyclone to replace the two existing GT710 cyclones installed in parallel. A GTD900 cyclone was chosen which required modifications / replacement of the launders, feed pipe and structural steel work to suit the new foot print.

HMA undertook all this work and supplied site with fully certified drawings for the complete scope of works including Cyclones, Launders and new structural work. The underflow launders were redesigned with the constraint of using the existing underflow discharge pipes. The overflow launders were replaced with minor changes due to the condition of these launders. The Y-piece was removed and new feed pipes installed as required.
