Case Study

SAFE MONITORING OF TAILINGS DAMS

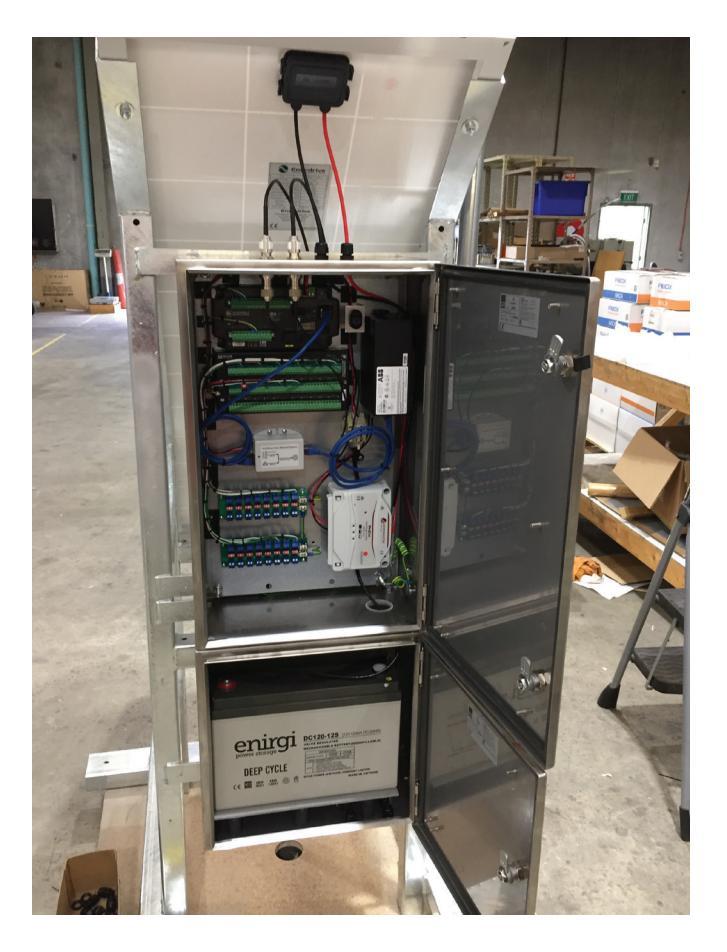
The nodes can be deployed in a star or mesh topology from the Hub. The respective node data loggers have an antenna and are powered by a single lithium D cell or solar, which provides years of power. Most major sensor types can be accommodated. The Hub has its own data logger for collating and transferring data to the client's local system and is housed in a protective enclosure.

The Hub uses an omnidirectional antenna and is typically powered by a solar panel or AC power. Automated, reliable and accurate sensor data was sent in real-time to the user's desktop PC, allowing for quick decision-making and data analysis from the remote site. In addition, HMA Geotechnical provided direct support and service remotely and in the field.
