Case Study

SITECH LINED DMC LOWER CONE & SPIGOT

DMC / SiTech / Coal

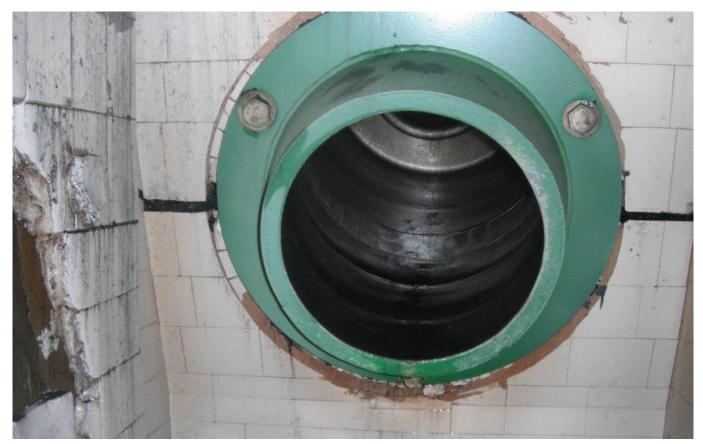
SiTech Spigot and Lower Cone

HMA replaced the Spigot and bottom third of the Lower Cone with a monolithic SiTech and the balance of the Lower Cone with engineered alumina tiles.

A substantial increase in life from 6 weeks to 20 weeks and longer if the feed chamber (NiHard) hadn't worn significantly to create damage and the interface of the two items. The Spigot and Lower Cone have been kept as a backup as they are still serviceable.
